Manhole Inspection Summary

Manhole # S13II_027MH

Location Address: **REAR 2753 NORTH AVE**

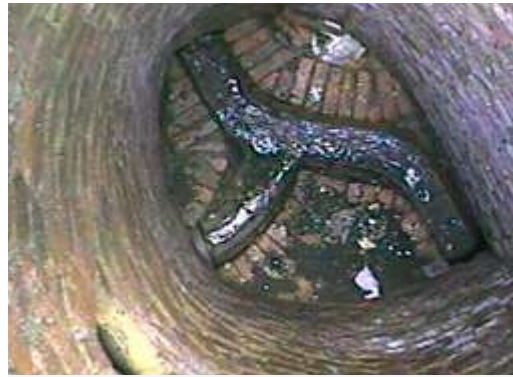
Top View

Steps Count: **6** Missing: **0** ☒ **Corroded**

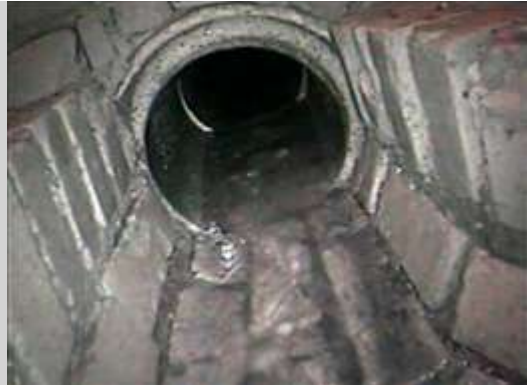
12 O'Clock Outflow

8 in. Circular Gravity Sewer
Pipe Out @ 12 O'Clock

Pipe Material: **Clay** ☐ Pipe Lined

Invert Depth: **10.87** (ft.) Flow Characteristics: **Slow**

Infiltration: **None** Pipe Seal Cond: **Sound**

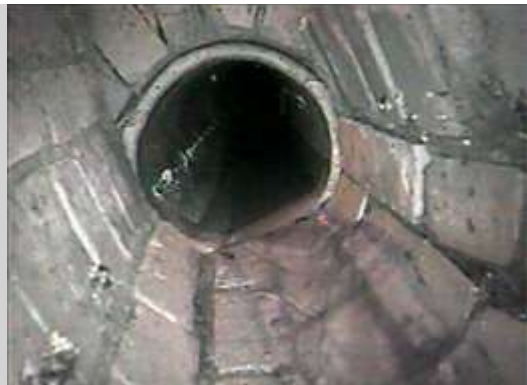
6 O'Clock Inflow

8 in. Circular Gravity Sewer
Pipe In @ 6 O'Clock

Pipe Material: **Clay** ☐ Pipe Lined

Invert Depth: **11.06** (ft.) Flow Characteristics: **Slow**

Infiltration: **None** Pipe Seal Cond: **Sound**

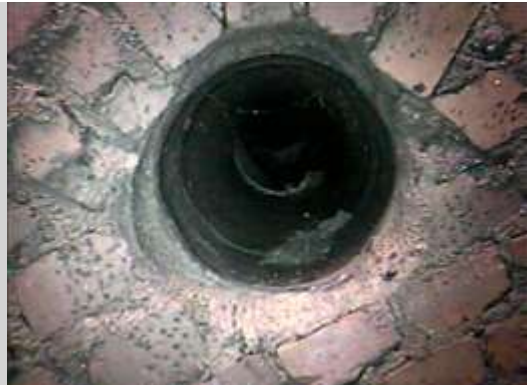
9 O'Clock Inflow

Pipe In @ 9 O'Clock

Pipe Material: **Clay** ☐ Pipe Lined

Invert Depth: **5.75** (ft.) Flow Characteristics: **Slow**

Infiltration: **None** Pipe Seal Cond: **Sound**

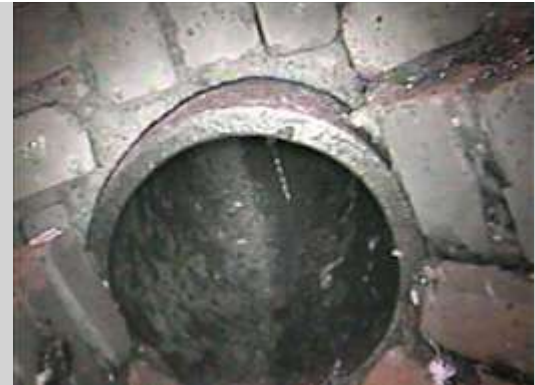
Drop In @ 9 O'Clock

Drop: **Outside** **Direct**

Inv Depth: **10.76** (ft.)

Drop Condition: **Open**
